# 207013 - Modena Mono mixer

Useful Information				
Minimum operating pressure	0.2 bar			
Maximum operating pressure	5 bar			
Guarantee length	2 years

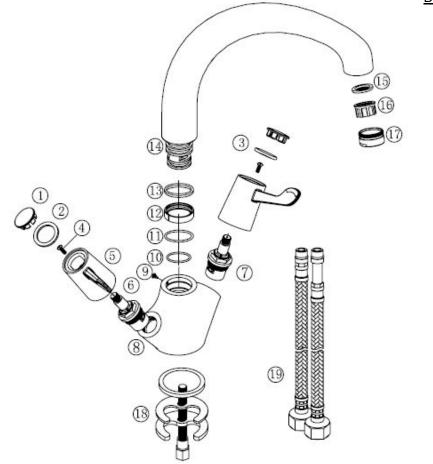
Exploded

Item Number	Supplier Ref	Item Description	Quantity	Material	Spares Available
1	P51-D	Indice	2	ABS	Yes
2	P51-B H	Indice Seat	1	PE	Yes
3	P51-B C	Indice Seat	1	PE	Yes
4	SC4-12S/L	Screw	2	Stainless Steel	Yes
5	H51-E	Handle	2	ZINC	Yes
6	VS01-C20	1/2" CD Valve	1	BRASS+EPDM+Cerami c Disc	Yes
7	VS01-C20	1/2" CD Valve	1	BRASS+EPDM+Cerami c Disc	Yes
8	M0113Z-01	Tap Body	1	BRASS	No
9	SC4-7.5S	Screw	1	Stainless Steel	Yes
10	OR014	O ring	1	EPDM	Yes
11	OR015	O Ring	1	EPDM	Yes
12	M33247-N1	Block Ring	1	POM	Yes
13	M0112-02-01	Washer	1	POM	Yes
14	167020-02	Spout	1	BRASS	No
15	A13-04X	Washer	1	EPDM+Stainless Steel	Yes
16	A13-02	Flow straightener	1	POM	Yes
17	A14-04	Flow straightener Shell	1	ABS	Yes
18	N24-F	Fixing kit	1	Steel+NBR+Brass	Yes
19	BZG12-1/2"-370	Braided Connectors	1	Stainless Steel+BRASS+ EPDM	Yes

- 1. Remove the cap (e), grub screw (a), handles (b).
- 2. Remove the valve (d) using a suitable spanner, clean thoroughly under cold water
- 3. to remove any build up of limescale or debris.
- 4. If necessary replace the valve.
- 5. Replace the valve (d) into the body, tighten the valve using a suitable spanner.
- 6. Replace the handles (b) and indice (f), tighten the grub screw (a).
- 7. Re-fit the cap (e) to handle.
