# 207005 - Curve Mono mixer

Useful Information				
Minimum operating pressure	0.3 bar			
Maximum operating pressure	5 bar			
Guarantee Length	5 years

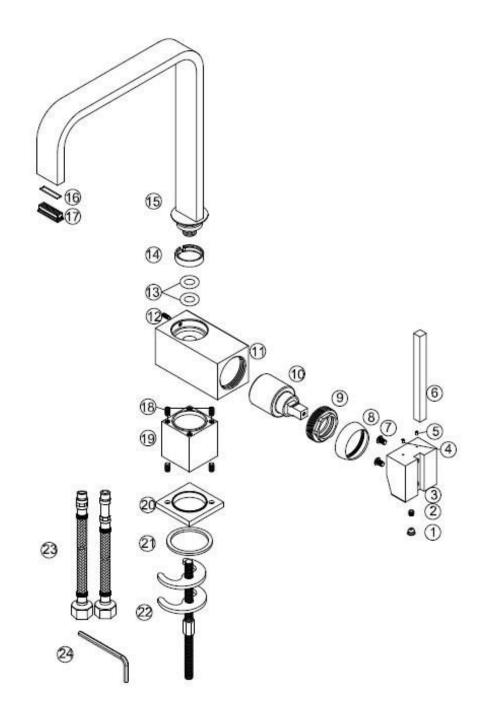
# Exploded Diagram

Item			Quantit		
Number	Supplier Ref	Description	У	Material	Spares Available
1	P90	Indice	1	ABS	Yes
2	SC5-4SN	Screw	1	Stainless Steel	Yes
3	H247L-Z	Handle Seat	1	ZINC	Yes
4	P247-C	Indice(Cold)	1	ABS	Yes
5	P247-H	Indice(Hot)	1	ABS	Yes
6	H247L-G	Handle Lever	1	BRASS	Yes
7	SC4-6P	Screw	2	Stainless Steel	Yes
8	S90	Valve Cover	1	BRASS	Yes

9	N31-B	Cartridge Clamp	1	BRASS	Yes
10	35D-1X	Cartridge Assembly	1	Ceramic Disc+PPM+NBR	Yes
11	M33247AZ-01	Tap Body	1	BRASS	No
12	SC4-10SND	Screw	1	Stainless Steel	Yes
13	OR040	O ring	2	EPDM	Yes
14	M33247-N1	Block Ring	1	POM	Yes
15	M33247A-02	Spout	1	BRASS	No
16	A247-02	Washer	1	EPDM	Yes
17	A247-01	Flow straightener	1	POM	Yes
18	SC5-8SN	Screw	4	Stainless Steel	No
19	M33247A-03	Body Seat	1	BRASS	No
20	N247-A	Flange	1	BRASS	Yes
21	N134-B02	Washer	1	EPDM	Yes
22	N247-B	Fixing kit	1	Steel+NBR+Brass	Yes
	BZG10-1/2"-45				_
23	0	Braided Connectors	1	Stainless Steel+BRASS+ EPDM	Yes
24	N106DM-03	Allen Key	1	STEEL	Yes

- 1. Remove the cap, grub screw, handle, cover and retaining nut.
- 2. Remove the cartridge using a suitable spanner, clean thoroughly under cold water to
- 3. remove any build up of limescale or debris.
- 4. If necessary replace the cartridge.
- 5. Replace the cartridge into the body, tighten the valve using a suitable spanner.
- 6. Replace retaining nut, cover and handle, tighten the grub screw and re-fit cap to
